Reprinted from "Wellhead Protection Study - Production Wells No. 1, 2 and 3 Gold Bar, Washington" Prepared by GeoEngineers October 1, 1997

Figure 5-1 Wellhead Protection Areas Wells 1,2 & 3

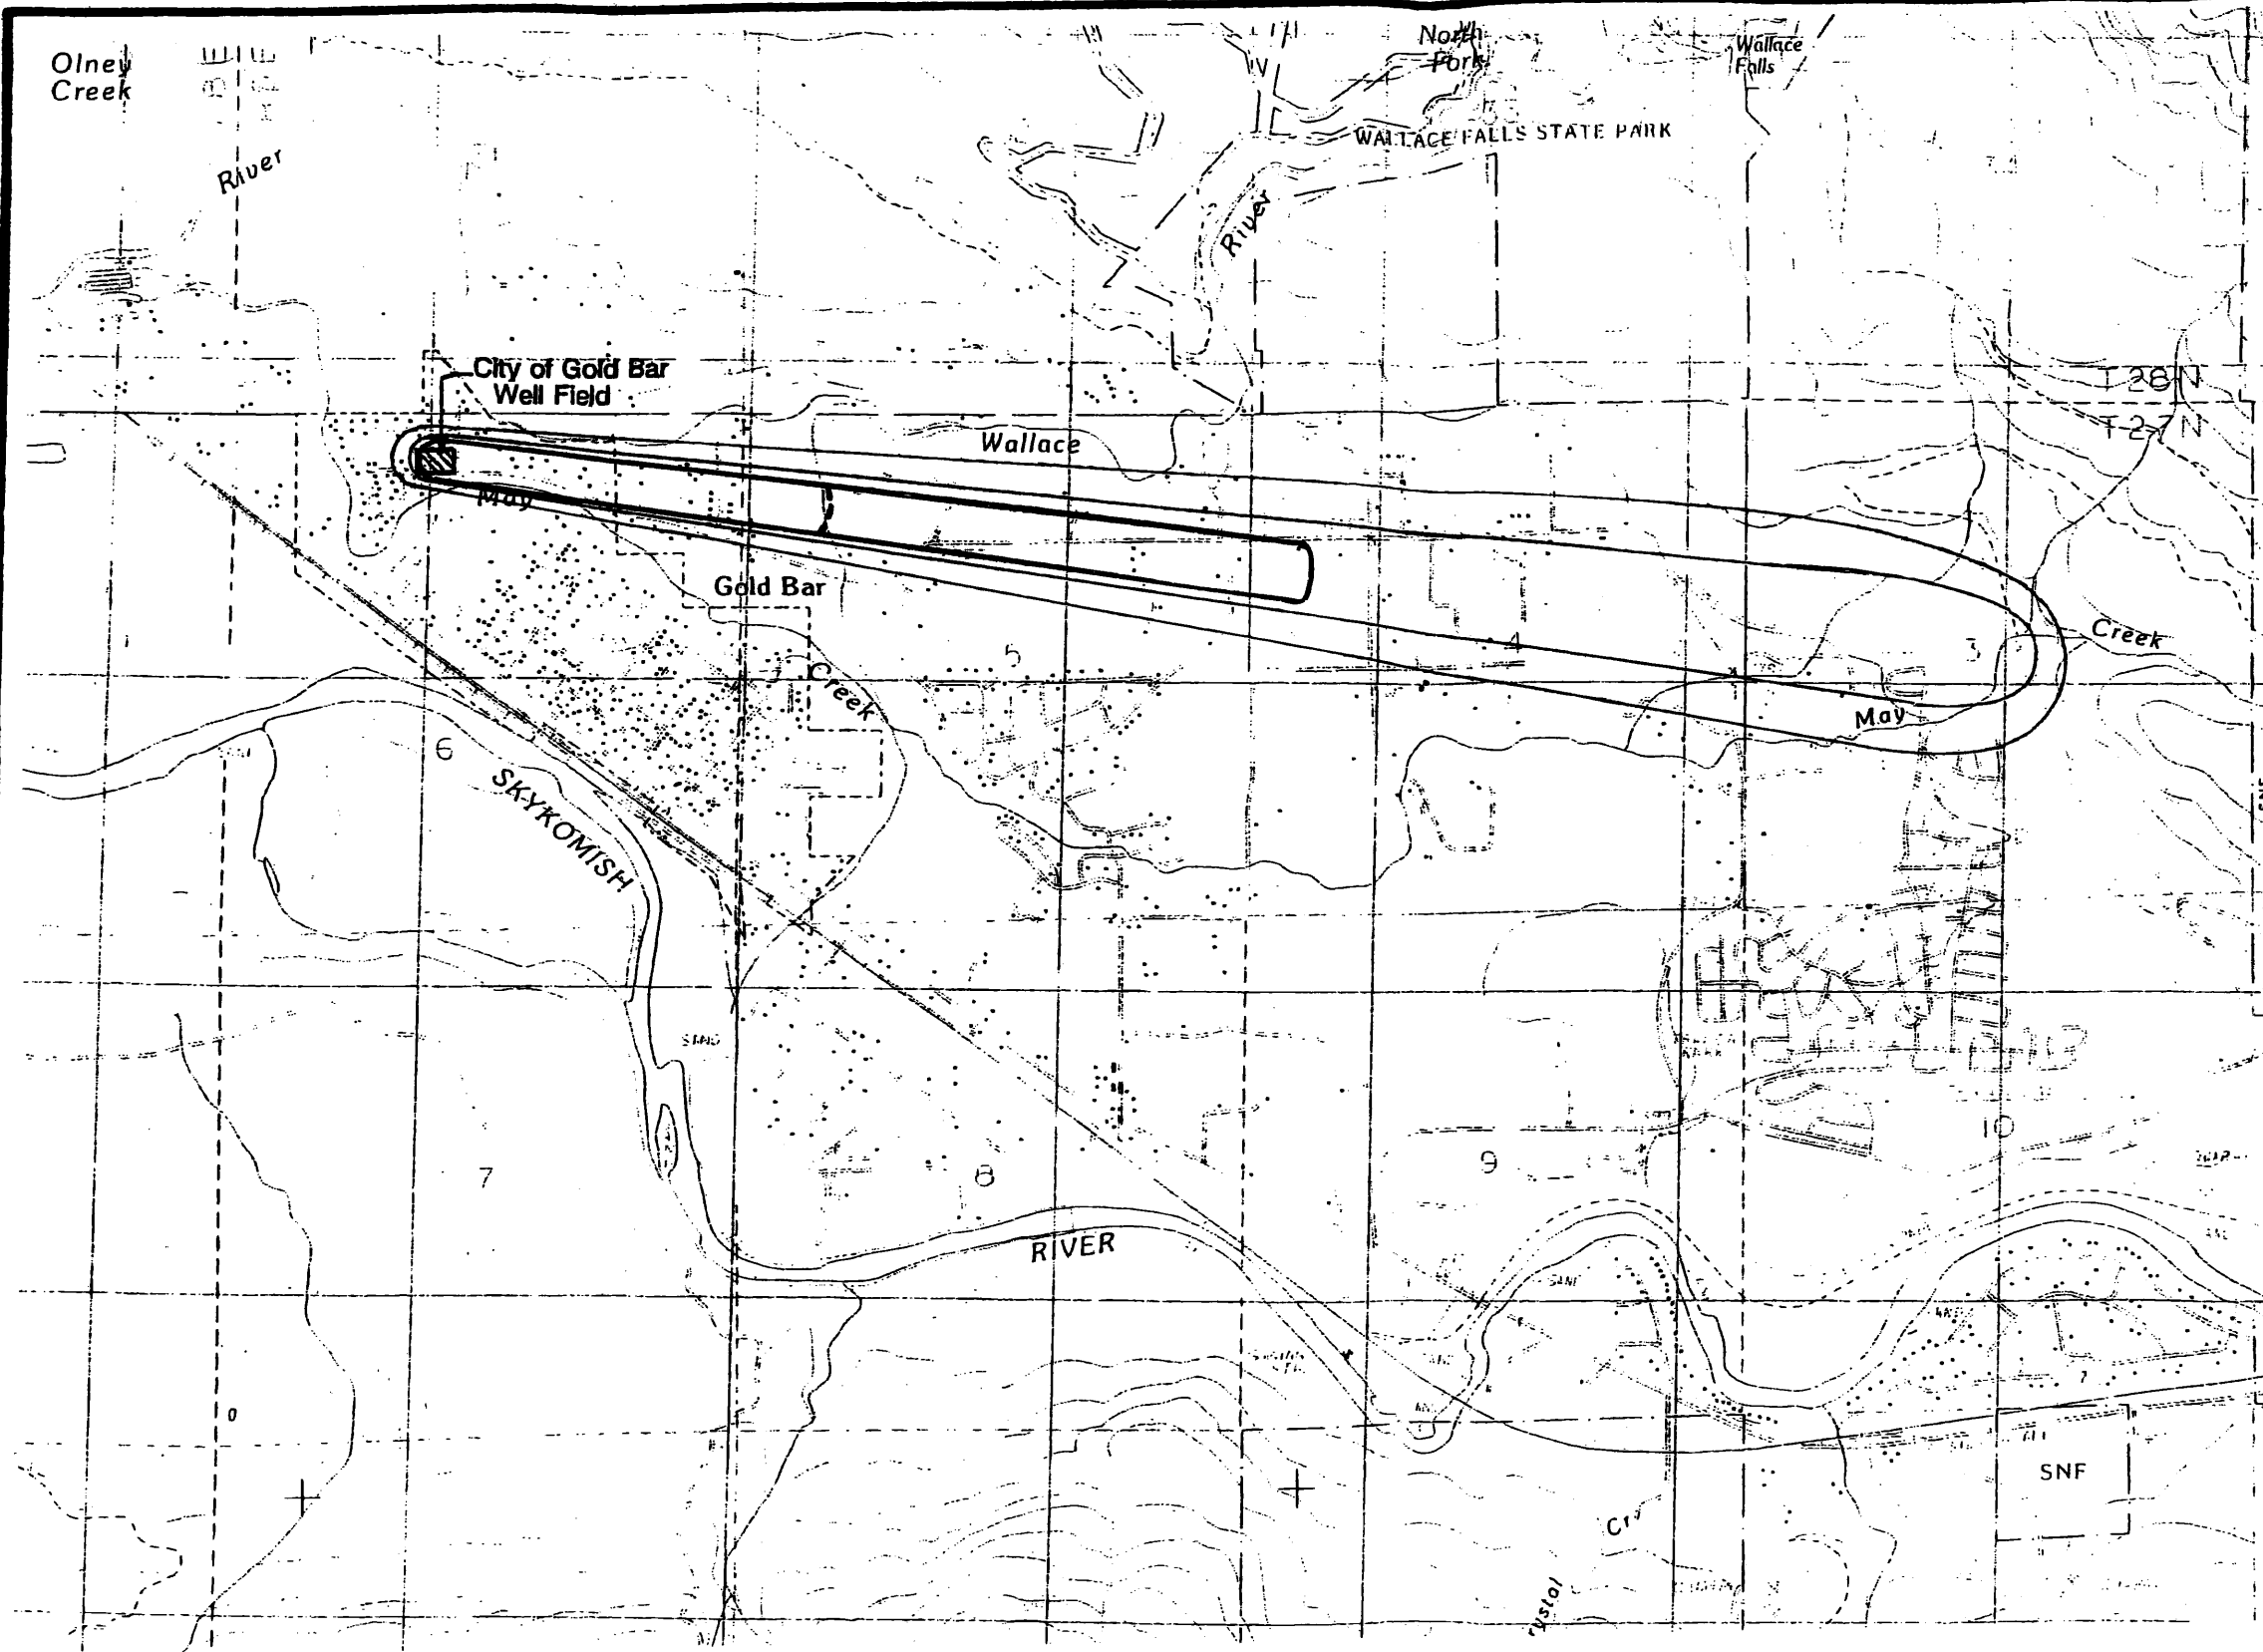
- EXPLANATION:
- 6-MONTH TOT
 - 1-YEAR TOT
 - 5-YEAR TOT
 - 10-YEAR TOT PLUS BUFFER
